Manhole Inspection Summary

Manhole # S27C1_014MH

Insp Date: **4/16/08 2:38 PM**

Location Address: **BEHIND 2357 SIDNEY AV.**

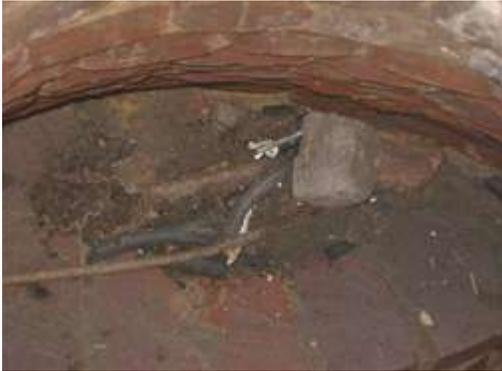
Defect 3

DEBRIS ON BENCH

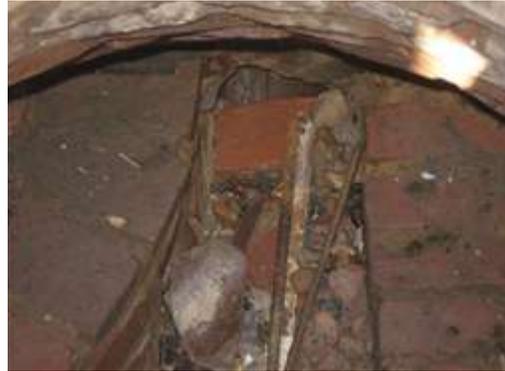
Defect 2

Comments **MH APPEARS TO BE ABANDONED - CANT GIVE ACCURATE 12 O CLOCK MEASUREMENT BECAUSE OF DBRIS IN CHANNEL. APPROXIMATE FIGURE ONLY.**

DEBRIS IN CHANNEL

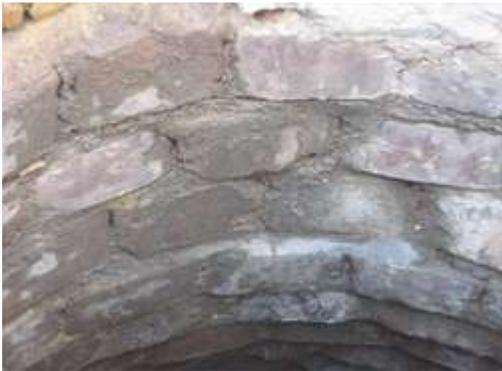
Defect 1

Cracks and Infiltration in Corbel

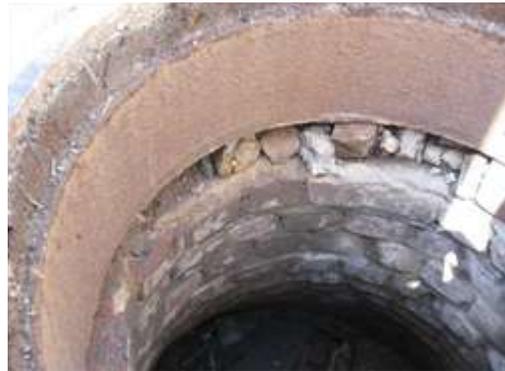
Cracks, Loose Bricks and Deteriorating Chimney, Chimney Infiltration, 1" Frame Offset

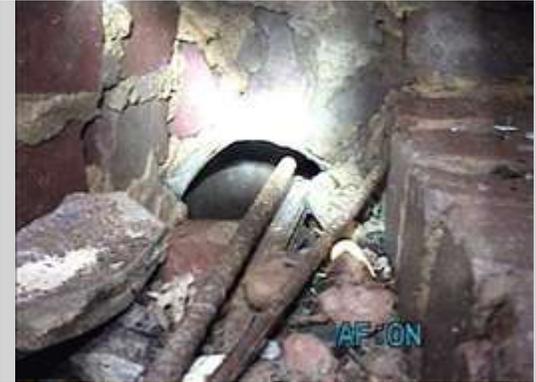
12 O'Clock Outflow

8 in. Circular Gravity Sewer
Pipe Out @ 12 O'Clock

Pipe Height: **0** (in.) Direct
Pipe Material: **Clay** Pipe Lined
Invert Depth: **5.72** (ft.) Flow Characteristics: **None**
Deposits: None Mud Sludge **Debris** Grease
Silt Depth: **6** (in.) Deposits Extent: **Heavy**
Infiltration: **None** Pipe Seal Cond: **Unknown**

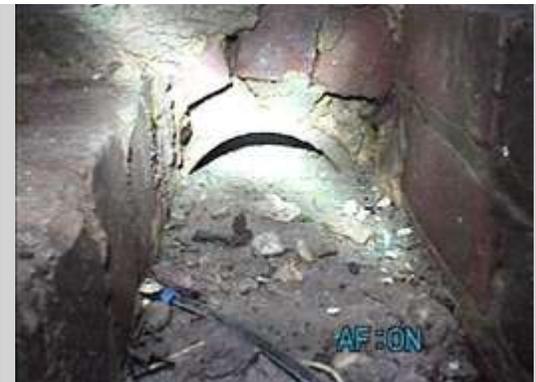
6 O'Clock Inflow

8 in. Circular Gravity Sewer
Pipe In @ 6 O'Clock

Pipe Height: **8.4** (in.) Rod and Bar (Angled)
Pipe Material: **Clay** Pipe Lined
Invert Depth: **5.60** (ft.) Flow Characteristics: **None**
Deposits: None **Mud** Sludge Debris Grease
Silt Depth: **6** (in.) Deposits Extent: **Heavy**
Infiltration: **None** Pipe Seal Cond: **Sound**

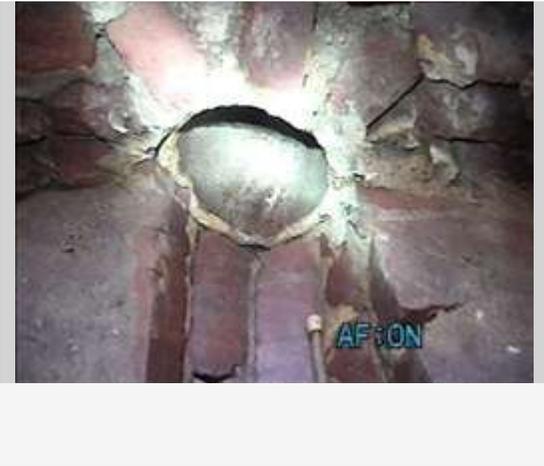
8 O'Clock Inflow

6 in. Circular Gravity Sewer

Pipe In @ 8 O'Clock

Connects To: **Stub connection / abandoned**
